NASA Engineering and Safety Center Technical Assessment Report	Version: 1.0
Title:	National Highway Traffic Safety Administration Toyota Unintended Acceleration Investigation	Page #: 1 of 177

**Technical Support to the National Highway Traffic Safety
Administration (NHTSA) on the Reported Toyota Motor
Corporation (TMC) Unintended Acceleration (UA)
Investigation**

January 18, 2011

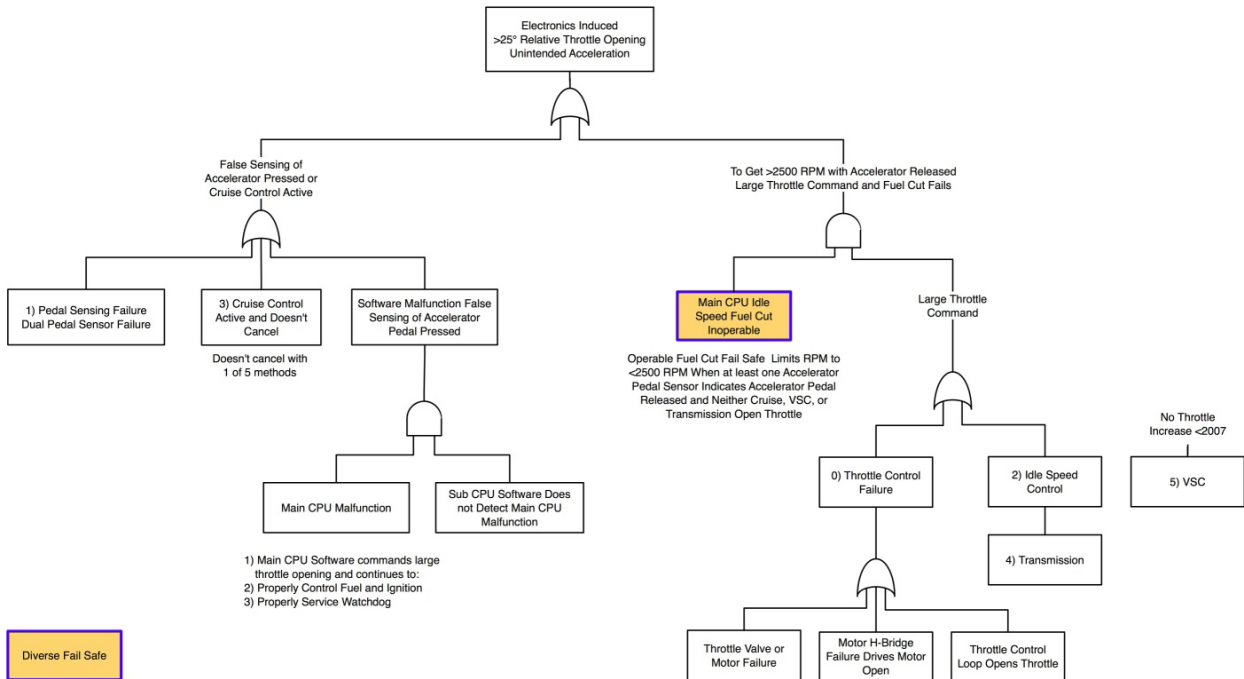
Figure 6.5.2.1-1. High Level Functional Fault Tree

Failures appearing as a valid pedal sensor signal to the Main CPU indicate the accelerator pedal is off idle or is pressed. These kind of functional failures are shown as the left branch of the functional fault tree on the left side of Figure 6.5.2.2-2.

To open the throttle unintentionally without detection, the design of the system requires the functional failure of the two VPA1 and VPA2 accelerator pedal sensor signals to mimic a valid signal, or a software fault indicating that the pedal is pressed. Figure 6.5.2.2-2 includes the lower level branches of the fault tree showing the functional component failures and DTCs serving to identify failures with accelerator pedal sensor components.

Comparing two sensors against each other can protect against failures as long as the failures do not corrupt both the sensors with valid voltages. The selection of VPA1 and VPA2 with an offset serves to protect the system from potential common mode failure causes that may affect both sensors in a way that they may mimic a valid signal. Section 6.6.2 describes accelerator pedal failure modes and the difficulty of detecting such failure modes engineered to mimic valid sensor signals.

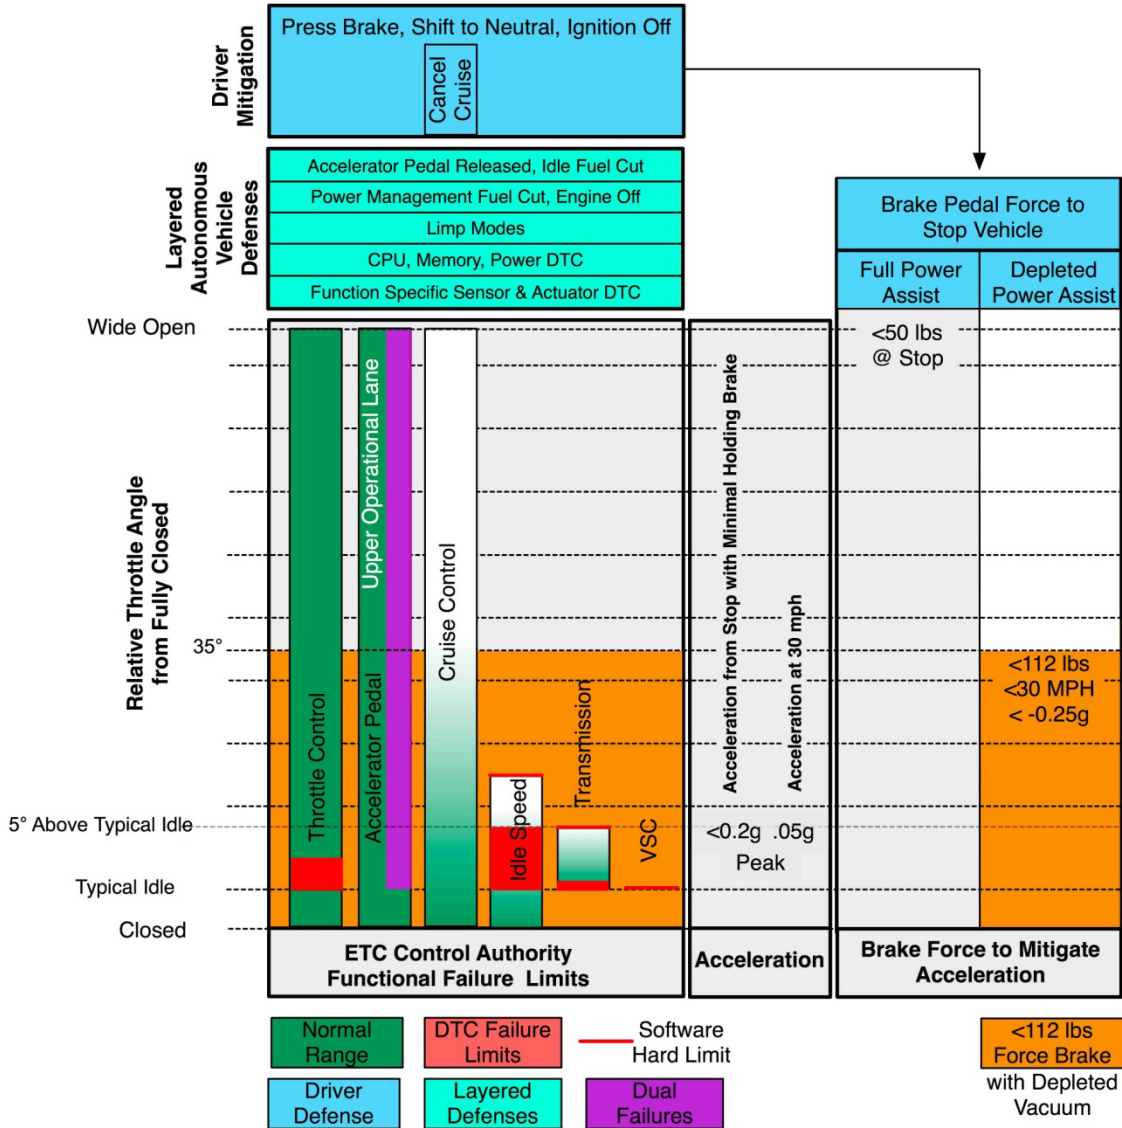
Figure 6.5.2.2-1. ETCS-i Throttle Angle Control Authority, Failure Limits, and Mitigation by Function

Figure 6.5.2.2-1 shows the relationship between throttle function control authority in green, the extent each function might open the throttle should the function fail in red along with any software hard limits as a red line. Layered autonomous failure responses are shown in green and driver mitigation options shown in blue. The range of throttle angles where the ability of brakes to slow the vehicle at >0.25 g even with depleted vacuum is shown in orange at angles <35 degrees (absolute). Figure 6.5.2.2-1 shows that throttle system failures shown in red are restricted to levels significantly below the ability of brakes to slow the vehicle at 0.25 g by the built in multilayered fail-safe defenses. Postulated accelerator pedal dual failure scenarios resulting in throttle openings are shown in purple.

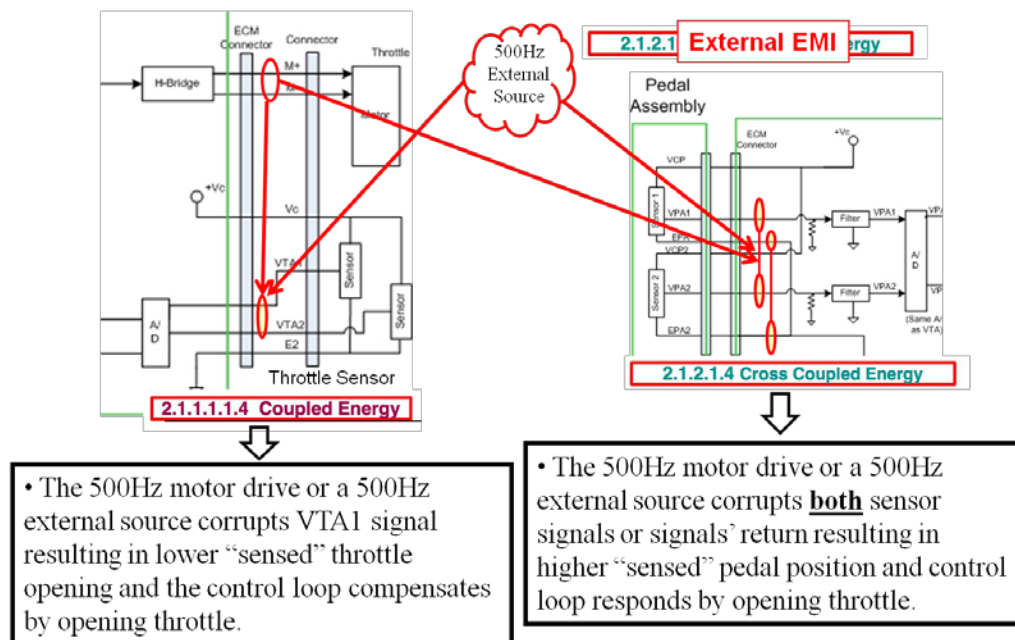
Figure 6.6.1.2-2. Summary of Postulated EMI Faults Identified from Fishbone Analysis

Figure 6.6.1.2-2 indicates the postulated EMI faults as identified from the fishbone analysis. Three different tests uncovered a 500 Hz sensitivity; the noise injection common to both VPA signals, noise injection on VTA1 signal, and the vehicle level conductive EMC testing.

On a simulator, a signal was injected in both VPA signals between their return lines (EPA1 & EPA2) and the ECM common ground. The results indicated a decreasing system response as the frequency was increased. However, as the (0.4Vpp) noise source on VPA signal return was increased to a frequency of 500 Hz, a 2 Hz signal (beat frequency with the internal 500Hz A/D sampling) of 0.2Vpp was observed on VTA as shown in Figure 6.6.1.2-3. Note the results shown are for a simulator without air flowing through the throttle body and are intended to describe the electrical response and not intended to describe an actual vehicle response.

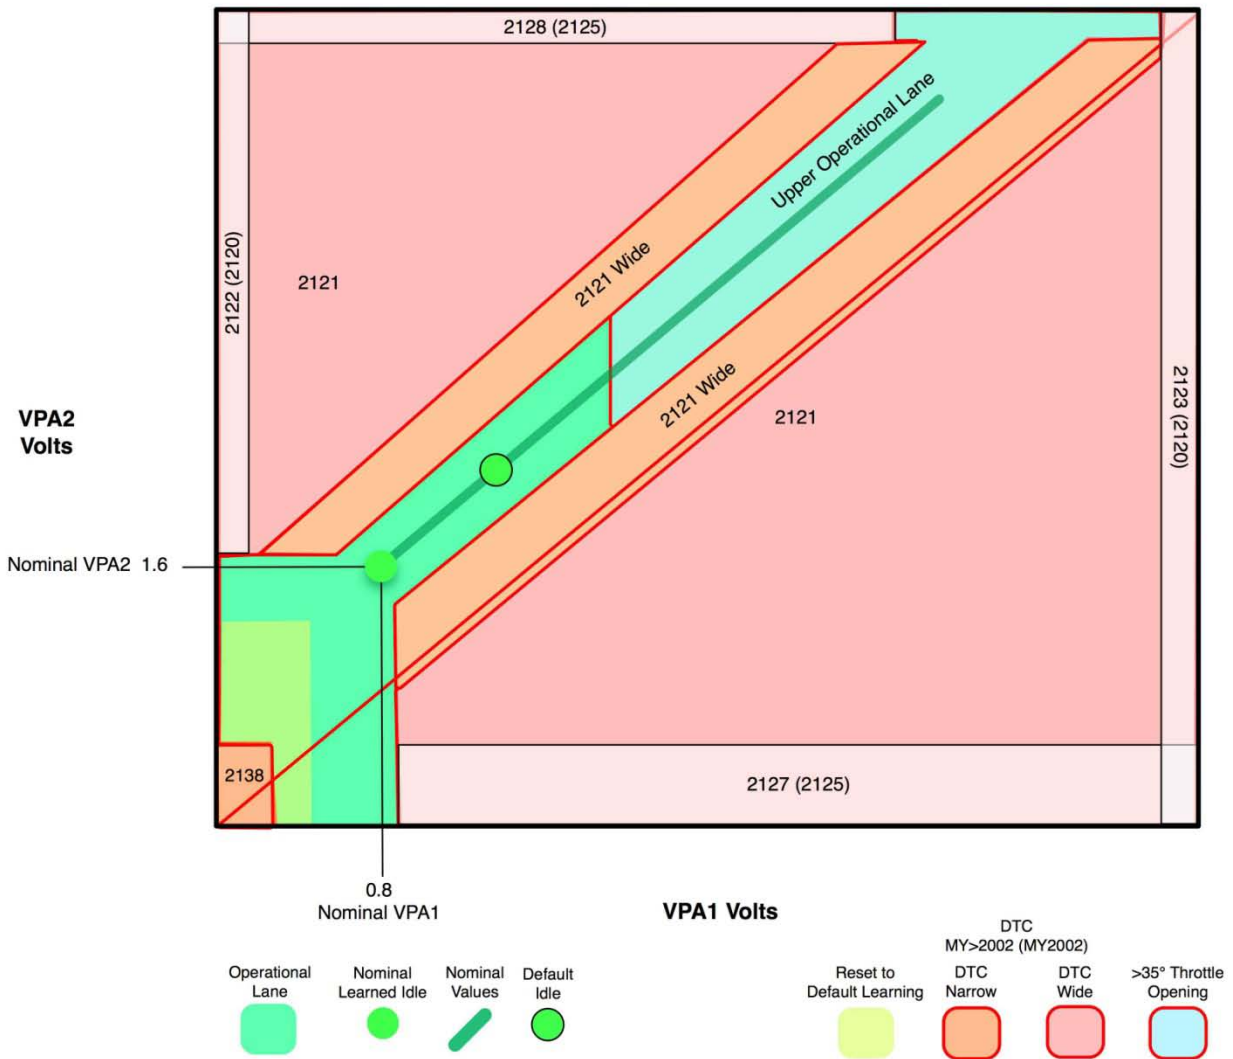
Figure 6.6.2.1-4. Notional Pedal DTC Map, 07 Camry V6, red is P2121 wide limit

Expanded thresholds for acceptable pedal values can occur whenever the battery voltage has been removed and restored, during certain pedal learning failures, and when the DTC P2121 has been detected. These expanded thresholds, or DTC wide thresholds, allow a wider range of pedal voltages to be accepted as operational. Nominally, after the foot-off-pedal position has been successfully learned, the operational lane of acceptable sensor values becomes reduced in width. A notional DTC map is shown in Figure 6.6.2.1-4. The wide allowable operating lane for signal voltages is shown in red.

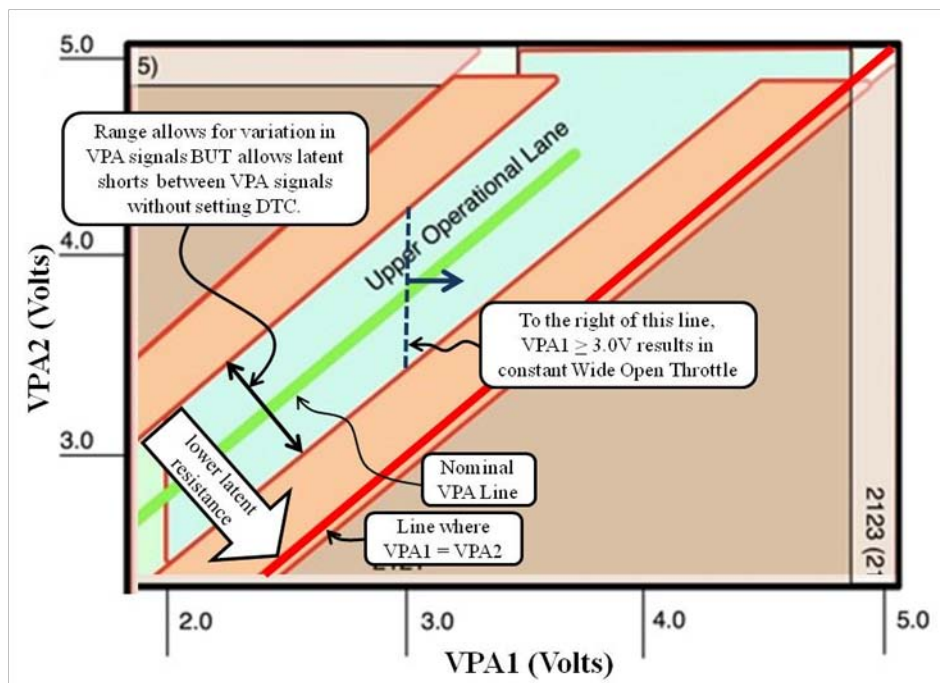
Figure 6.6.2.2-2. The upper operational lane with the latent fault influence and WOT location.

VPA signals if it were to occur can decrease the nominal line in the downward and right direction approaching the $VPA1 = VPA2$ line. In order to avoid generating a DTC, such a latent resistance must not result in the VPA signals going outside the operational lane. That is, a latent resistance can move the VPA signal from the current line position to the edge of the operational lane. For a Hall Effect sensor and nominal VPA signals (green line), the minimum latent resistance is approximately 200 ohms (to stay in the operational lane if a secondary VPA2 short to +V supply occurs). However, if the VPA signals were closer to the lower operational lane limit, then the minimum latent resistance would be greater, and conversely if the actual VPA signals were closer to the upper operational lane limit, then the minimum latent resistance would be lower.

The other key point of Figure 6.6.2.2-2 is the relationship between VPA1 and the throttle position. For nominal VPA signal voltages, VPA1 greater than or equal to 3.0V corresponds to WOT or 90 degree throttle opening. For VPA1 voltages greater than 3.0V, the throttle position maintains a constant WOT. This condition is true only for nominal idle voltages of VPA1 equal 0.8V and VPA2 equals 1.6V. For default learning where [redacted] V, then the WOT VPA1 voltage would be [redacted] higher or VPA1 equal or greater than [redacted] V.

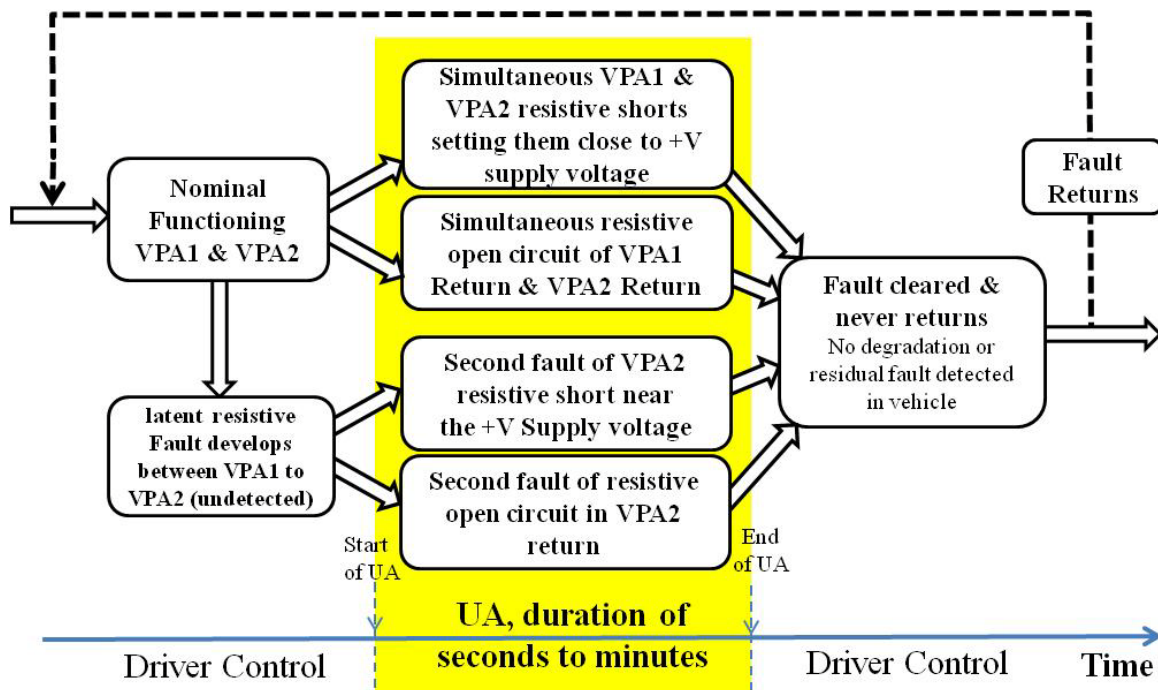
Figure 6.6.2.2-3. Chronological steps of a dual fault in the upper operational lane

due to two anomalous resistive current paths placing VPA1 and VPA2 in the upper operational lane which may last from seconds to minutes followed by the fault clearing allowing driver control again with the fault condition never occurring again in most cases and to not be detected when taken for service in all cases. In VOQ cases analyzed, this type of UA has been reported although in the majority of incidents it was experienced only once. In no known cases (VOQ or otherwise) have the large throttle opening UA conditions been predictably repeated under normally occurring conditions except during NESC tests. Figure 6.6.2.2-3 also includes the possible postulated fault steps in which a UA can occur; either from a latent fault that resides in the design for a period of time then later the second fault condition occurs or also for two faults that occur simultaneously (both within 0.5 seconds time period).

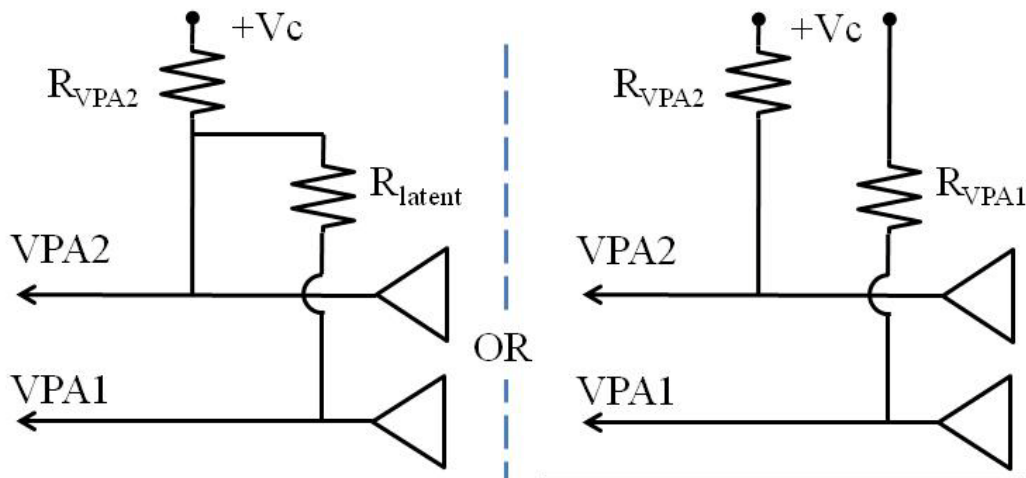
Figure 6.6.2.2-4. Fault resistance locations for the postulated double fault of shorts to the +V supply

sensors may not. Figure 6.6.2.2-4 indicates the location of the latent fault in relationship to the VPA signals and the relation of the latent resistance to the resistances for the dual fault to the +V supply.

A latent fault could exist between the two VPA signals and go undetected (in Hall Effect sensors) within a limited range of resistance values and at some later time the second fault to VPA2 could occur placing the two signals in the upper operational lane. The low output impedance of the Hall Effect sensor amplifier allows the latent resistance to be present yet not impact the circuit performance. As will be shown later, the potentiometer sensor has a much higher output resistance and latent faults of the same resistance (as Hall Effect latent resistance) will result in the signals going outside the operational lane and generating a DTC for most, but not all conditions.

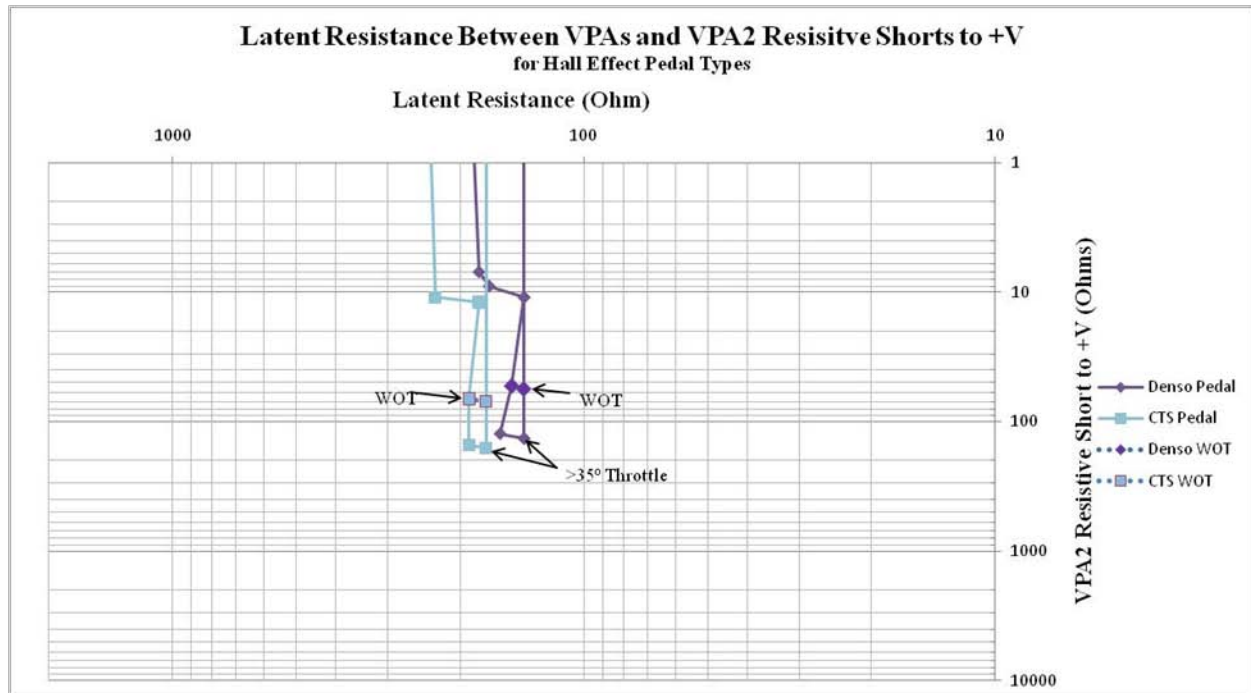
Figure 6.6.2.2-5. For Hall Effect type pedals, resistance range required for latent fault between VPA signals and second fault of VPA2 resistive shorted to +V

The other failure mode identified is a latent fault between the VPA signals with the second fault being a resistive open circuit on the VPA2 return line. The NESC team studied this effect (see Appendix C). For the CTS pedal tested, there was not a resistance range, but rather a single resistance of approximately 170Ω between the VPA signals which placed them in the upper operational lane with a VPA2 return line open circuit of $8k\Omega$ or greater (and not generate a DTC). Since the fault was at the edge of the operational lane, due to natural variances other CTS pedals may have a narrow resistance range allowing this fault to occur and not generate a DTC for the full range of pedal stroke.

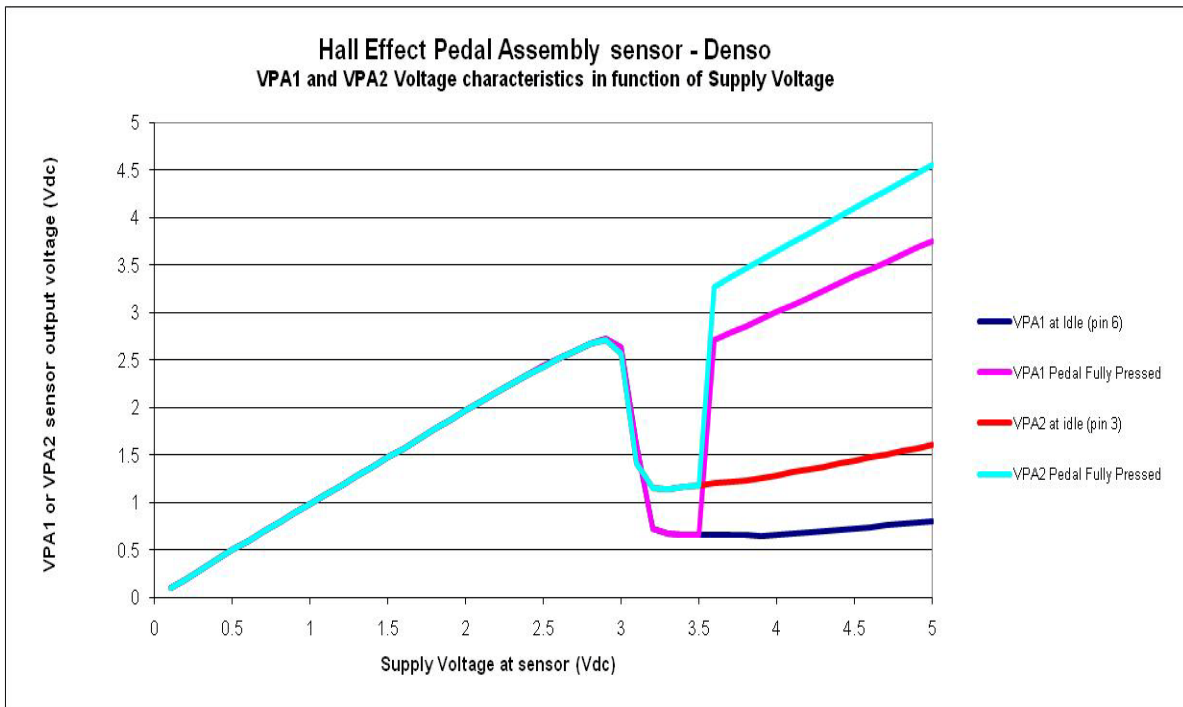
Figure 6.6.2.2-7. Denso Hall Effect sensor outputs as a function of the lower supply voltage

As shown in Figure 6.6.2.2-7, for the Denso pedal, as the supply voltages drop the output voltages also drop concurrently, however, at approximately 3V range sensor output then jumps to the supply voltage and follows the supply voltage linearly to zero. If the VPA signals converge as shown (within <0.4V) then a DTC is generated. However, depending on the fault conditions, there are voltage combinations which may put the VPA signals in the operational lane and not set a DTC. For these conditions, the Denso pedal would be subject to simultaneous dual resistive open circuit in the +V supply faults similar to the other postulated faults. However, the peak VPA signal voltage is approximately 2.7V. If VPA2 was at the maximum 2.7V, then to stay in the operational lane, then VPA1 can be no more than 2.2V or just inside the upper operational lane. This fault is similar to the postulated simultaneous resistive faults conditions in the return, but the maximum throttle opening is significantly less. Since the consequence is significantly less (just inside the upper operational lane) determining the exact resistance ranges was not explored for this unique case.

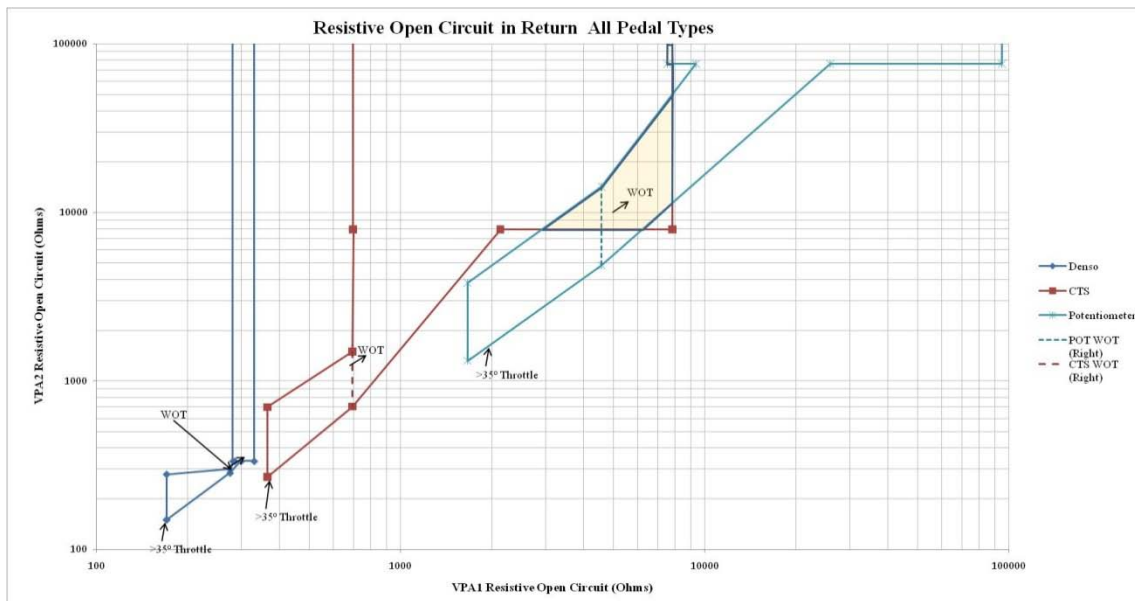
Figure 6.6.2.2-8. Resistance range required for simultaneous resistive open circuit in the VPA return line for all three pedal types

Again, assuming the pedal is at the physical idle position, Figure 6.6.2.2-8 shows the necessary resistance range required for resistive open circuits in the VPA signal return for all three pedal types to not generate a DTC. Note that resistance ranges do not overlap and therefore there is not one set of conditions common to all pedal types which could cause a large throttle opening UA. This implies that if this postulated fault was occurring, then the conditions in addition to the other restrictions previously described would need to be uniquely tailored for each pedal type rather than common across all pedal types to avoid generating DTCs.

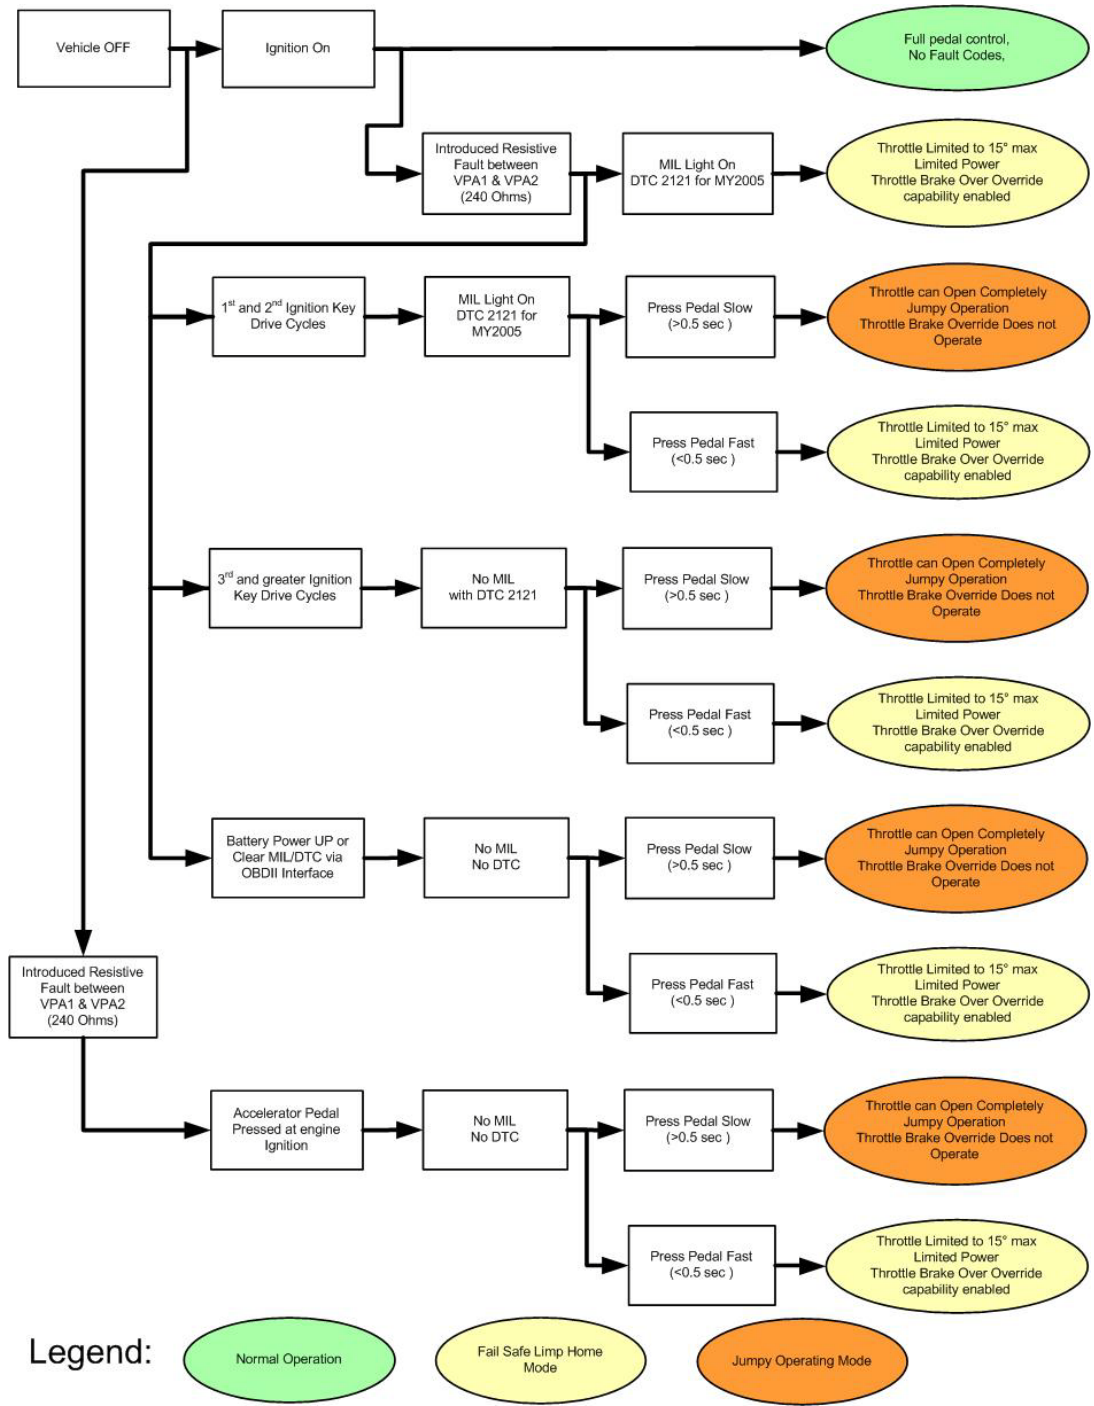
Figure 6.6.2.3-2. Pedal Resistive Fault Event Sequence Diagram

After the battery is disconnected and then reconnected or the DTCs are otherwise cleared, the DTC and MIL does not return with throttle response depending on pedal application as described above.

As shown on the 5th path, if the resistive short occurs while the vehicle is off, starting the vehicle with the accelerator pedal partially depressed will not set a DTC. The accelerator responds as described above.

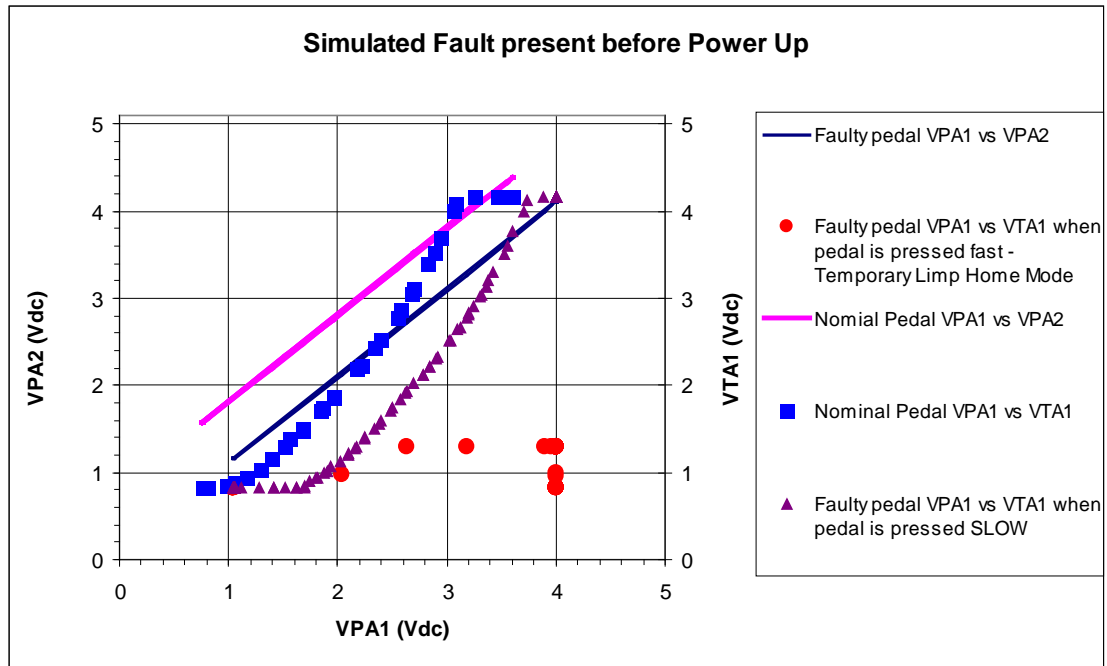
Figure 6.6.2.3-3. Simulated Pedal Fault Behavior

The following plot, Figure 6.6.2.3-3., was generated from tests performed on the MY 2006 V6 ETC simulator. A short of 248 ohms was introduced between VPA1 and VPA2.

The nominal pedal relationship between VPA1 and VPA2 is depicted in pink. The pedal relationship with the 248 ohm short is offset below and to the right in dark blue.

If the 248 ohms fault occurs after the system is powered up, a limp home mode will govern the throttle operation, thus limiting the throttle opening as described by the red dot curve of Figure 6.6.2.3-3. The throttle opens smoothly and is limited to approximately 15 degrees above idle. Also noted is the throttle closing as the throttle brake override activates when the brake pedal was applied after the pedal reached its fully pressed position.

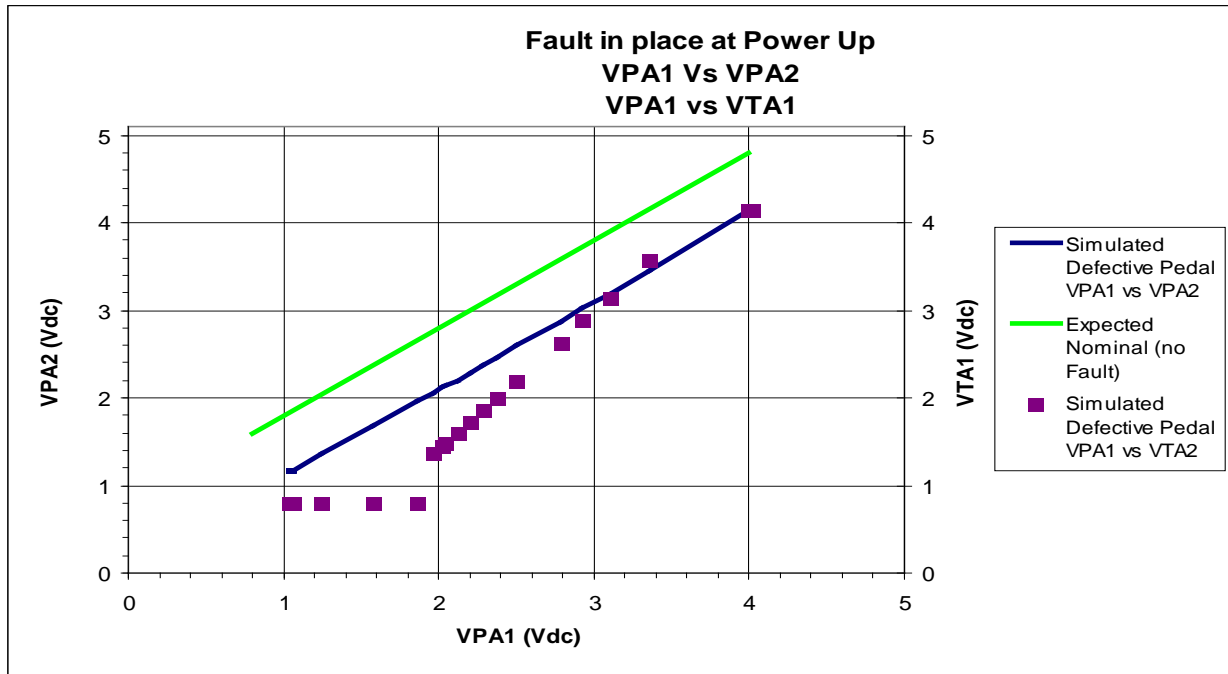
Figure 6.6.2.3-4. Fault in Place at Power Up

The following plot, Figure 6.6.2.3-4, was generated from tests performed on the 2005 L4 ETC simulator. A short of 248 ohms was introduced between VPA1 and VPA2.

The nominal pedal relationship between VPA1 and VPA2 is depicted in green. The pedal relationship with the 248 ohm short is offset below and to the right in dark blue.

When the pedal is pressed slowly, more than 0.5 seconds through the first 0.5 inches of pedal travel, no throttle opening occurs during the initial pedal travel. Then a sharp increase in throttle valve opening occurs. After this sharp increase, the throttle valve can be controlled by the pedal input up to the maximum throttle valve opening, where it limits and no longer increases. This is illustrated by the purple squares. Throttle brake override capability is not available under this condition.

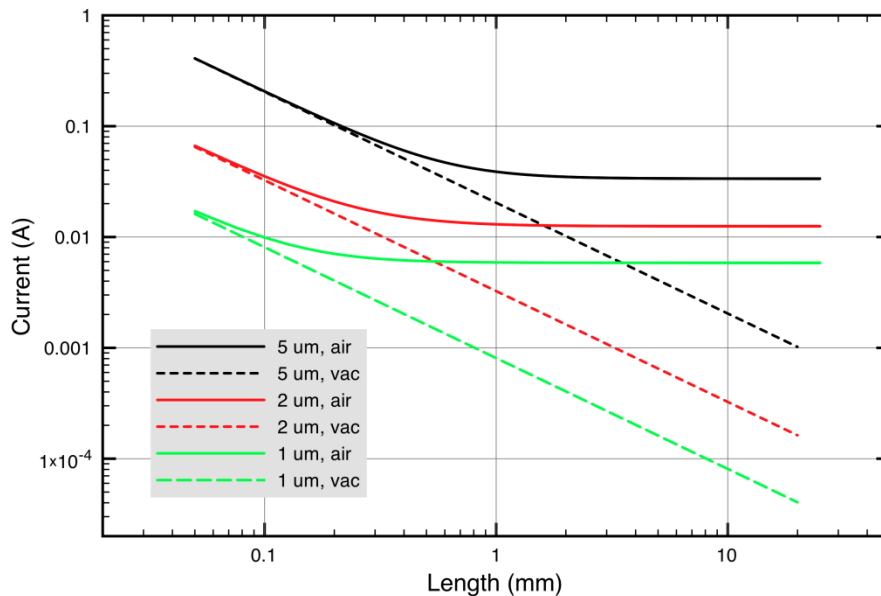
Figure 6.6.2.3-7. The current to bring a tin whisker to its melting temperature versus the length of the tin whisker¹⁹

This bridging whisker’s thickness is calculated to be approximately 1.7 μm , based on its length (1.9 mm), its electrical resistance (240 ohms), and the electrical properties of tin.

The electrical current needed to melt a whisker of this length and thickness in air is approximately 5 mA, as shown in Figure 6.6.2.3-7. This current raises the temperature to the melting point of tin, 232 C, and increases the resistance of this metal whisker to about 410 ohms. The electrical characteristics of the dual potentiometer circuit cannot place such a large current through this whisker, bridging VPA1 and VPA2; thus, its survival (i.e., non-melting during the operation of the car) is expected. Electrical analysis by the NESC team determined that less than 1 mA will typically flow in a fault between VPA1 and VPA2 and a second similar fault to Vc, if it were to occur, would result in a higher current, approximately 5 ma, through that fault, but not enough to ensure melting.

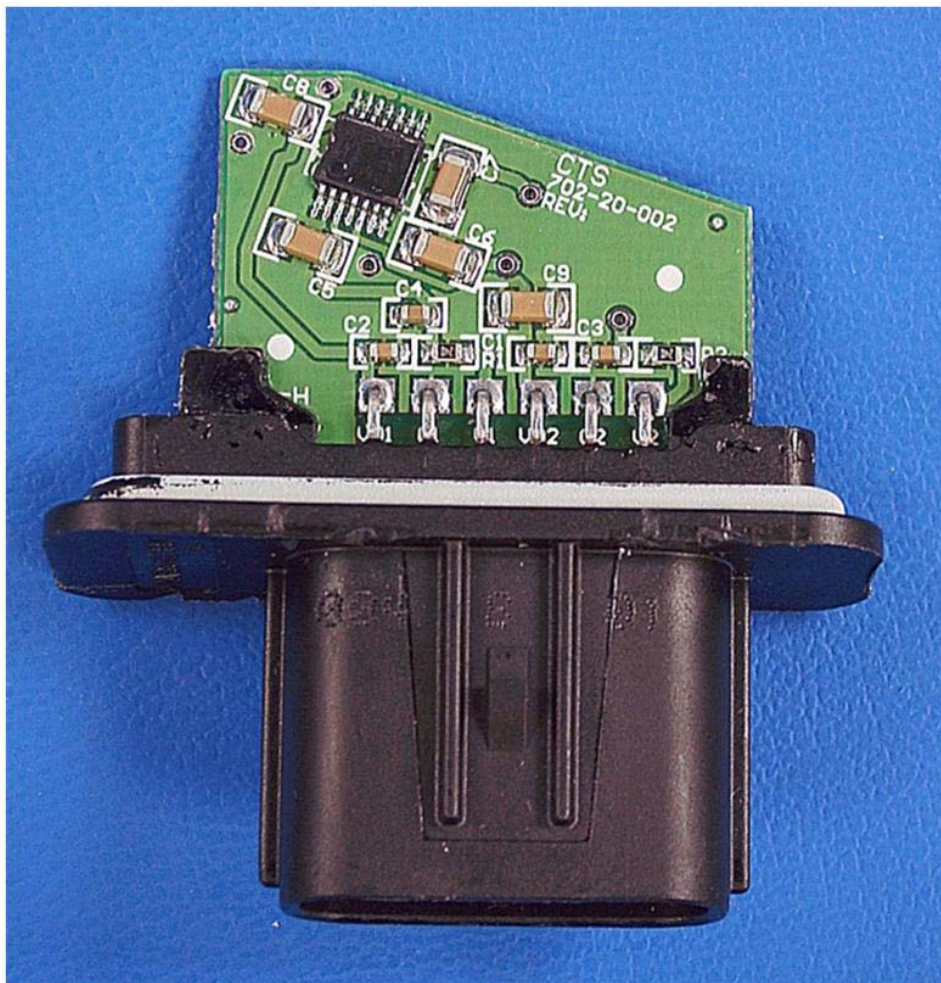
Figure 6.6.2.3-9. CTS Hall Effect Pedal Assembly Connector and Circuit Card

Destructive physical analysis of a CTS pedal assembly showed that the circuit card that contains the Hall Effect sensors is directly mounted to the connector as shown in Figure 6.6.2.3-9.

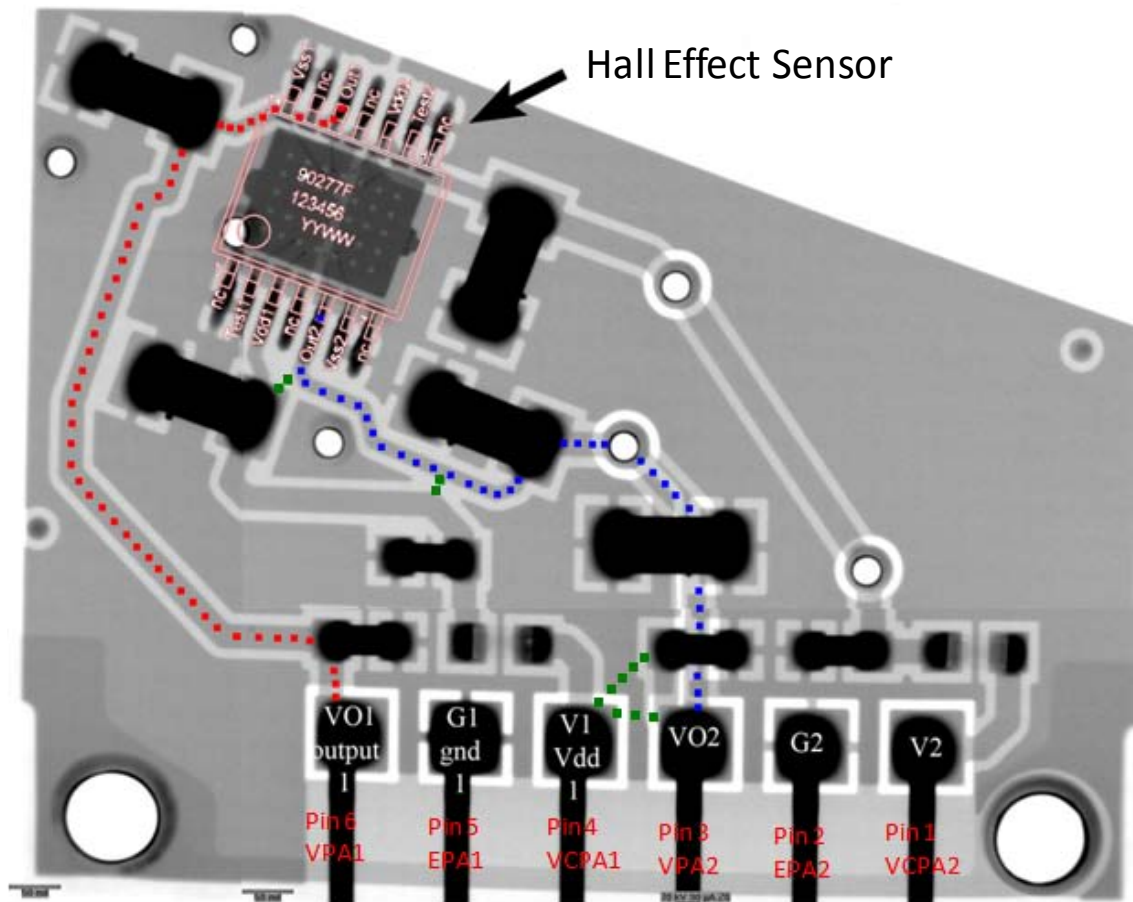
Figure 6.6.2.3-10. CTS Pedal Assembly Circuit Board X-ray Detail

Figure 6.6.2.3-10 shows the CTS pedal assembly connector contact board attachment points and signal traces for VPA1 (red dots) and VPA2 (blue dots), which are physically separated. Also, the VPA1 circuit trace appears to have ground potential traces on both sides of its length. VPA2

has ground potential traces along most of its length, but there are four identified regions (green dots) where VPA2 is in proximity to +5V (VCPA1). Two of these have capacitors with tin plated end caps. A survey of solder joints showed them to be a lead/tin alloy, which is resistant to tin whisker formation. Also the circuit card has an insulating protective conformal coating over it and the parts, although some gaps in the coating were detected. The connections between the circuit card and the connector pins at the bottom of Figure 6.6.2.3-9 has pure tin, but as previously noted the VPA1 and VPA2 signals have wide separation. This configuration appears to be more robust against undesirable tin whisker shorts (particularly those between VPA1 and VPA2) than the potentiometer configuration, previously shown, where VPA1 and VPA2 pin and signal conductors are next to each other and +5V (VCPA1) is next to VPA2 with no conformal coating (see Figure 6.6.2.3-10).

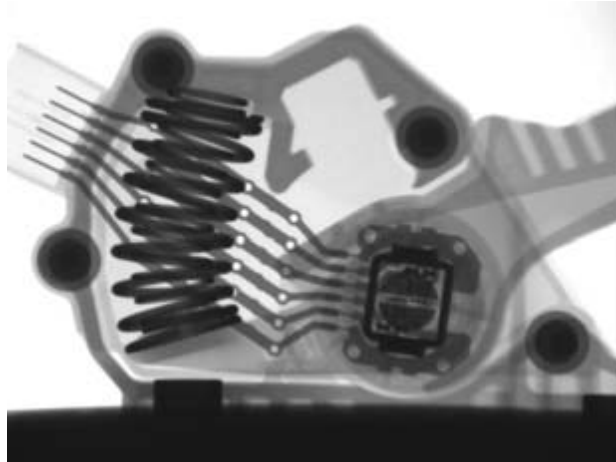
Figure 6.6.2.3-11. X-ray of Denso pedal assembly

X-ray and destructive physical analysis of the Denso Hall Effect Sensor provided construction details as shown in Figure 6.6.2.3-11.

The examination revealed that the solder used on the printed circuit board was a “lead free” tin alloy called Sn-Ag-Cu (“SAC”), which is less prone to formation of tin whiskers than pure tin solder. There were no traces of pure tin coating on connector pins and no solder cracks or cold solders. The examination found that the printed circuit board is not conformal coated and part of the enclosure of the ECM is made out of an aluminum-zinc alloy which can develop whiskers. However, the inspection of this ECM revealed no tin or zinc metallic whisker growth, nor precursors that sometimes predict the later growth of metal whiskers.

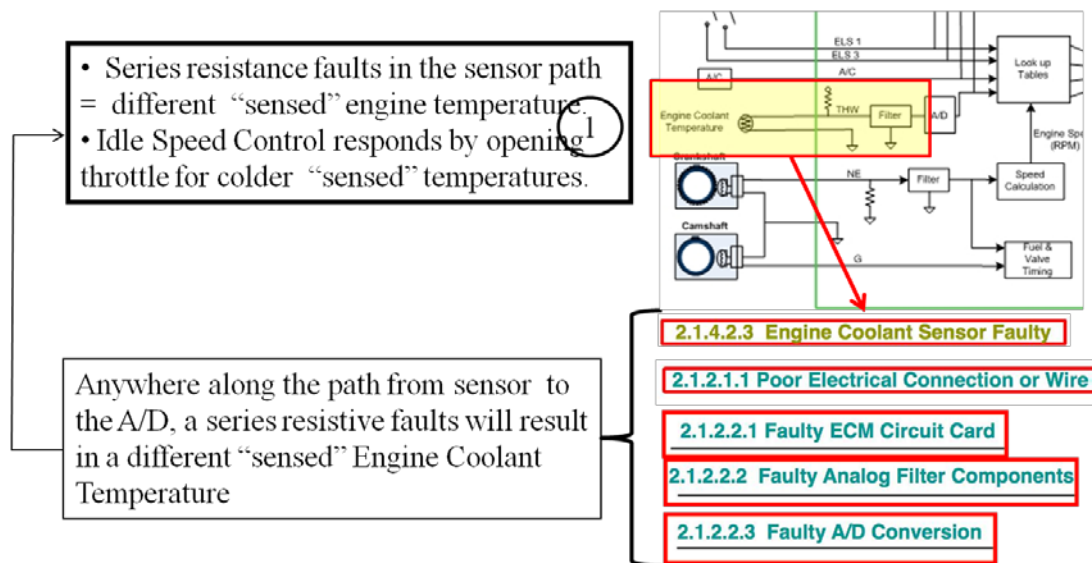
Figure 6.6.3.4-1. Summary of postulated faults identified by Idle Speed Control Function Fishbone Diagram

Figure 6.6.3.4-1 shows the summary of postulated faults identified by the fishbone for the ISC functional area. Based on the understanding of the ISC design as described, the ISC system was reviewed for sensitivities where a postulated fault could result in an increase in engine speed. The fishbone was used to identify potential sensitive entry points into the ISC loop. The fishbone identified a poor electrical connection, wiring or faulty engine coolant temperature sensor that may create the potential fault listed below. The next section details postulated faults and effects for the ISC.

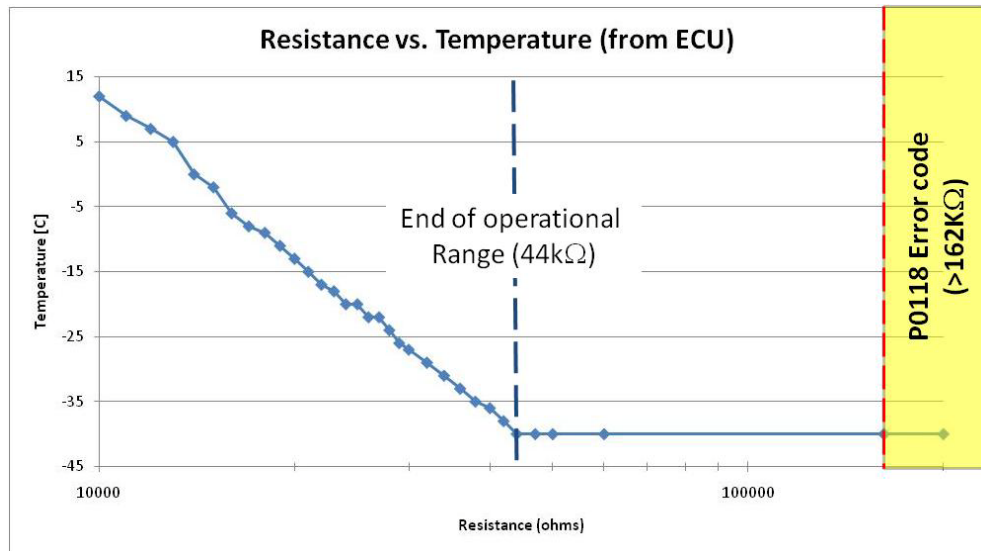
Figure 6.6.3.7-2. Upper resistance range of the Coolant Temperature Sensor including the DTC error range

For the coolant temperature sensor, the ECM software look-up table increases the target rpm directly proportional to the temperature reaching a maximum at -40C. When tested on a vehicle, the vehicle would not start when the engine was warm. Additionally, as the engine warmed the vehicle did not run smoothly, therefore the driver would have other indication the vehicle was not operating properly. These symptoms were not seen in the VOQs and there is no incidence of DTCs or repairs, therefore this postulated failure is not supported by the available data.
